**NASA CONTRACTOR  
REPORT**

NASA CR-2884

**LOAN COPY: RETURN TO  
AFWL TECHNICAL LIBRARY  
KIRTLAND AFB, N. M.****MODEL PREDICTIONS OF WIND  
AND TURBULENCE PROFILES  
ASSOCIATED WITH AN ENSEMBLE  
OF AIRCRAFT ACCIDENTS**

AERONAUTICAL RESEARCH ASSOCIATES OF PRINCETON, INC.

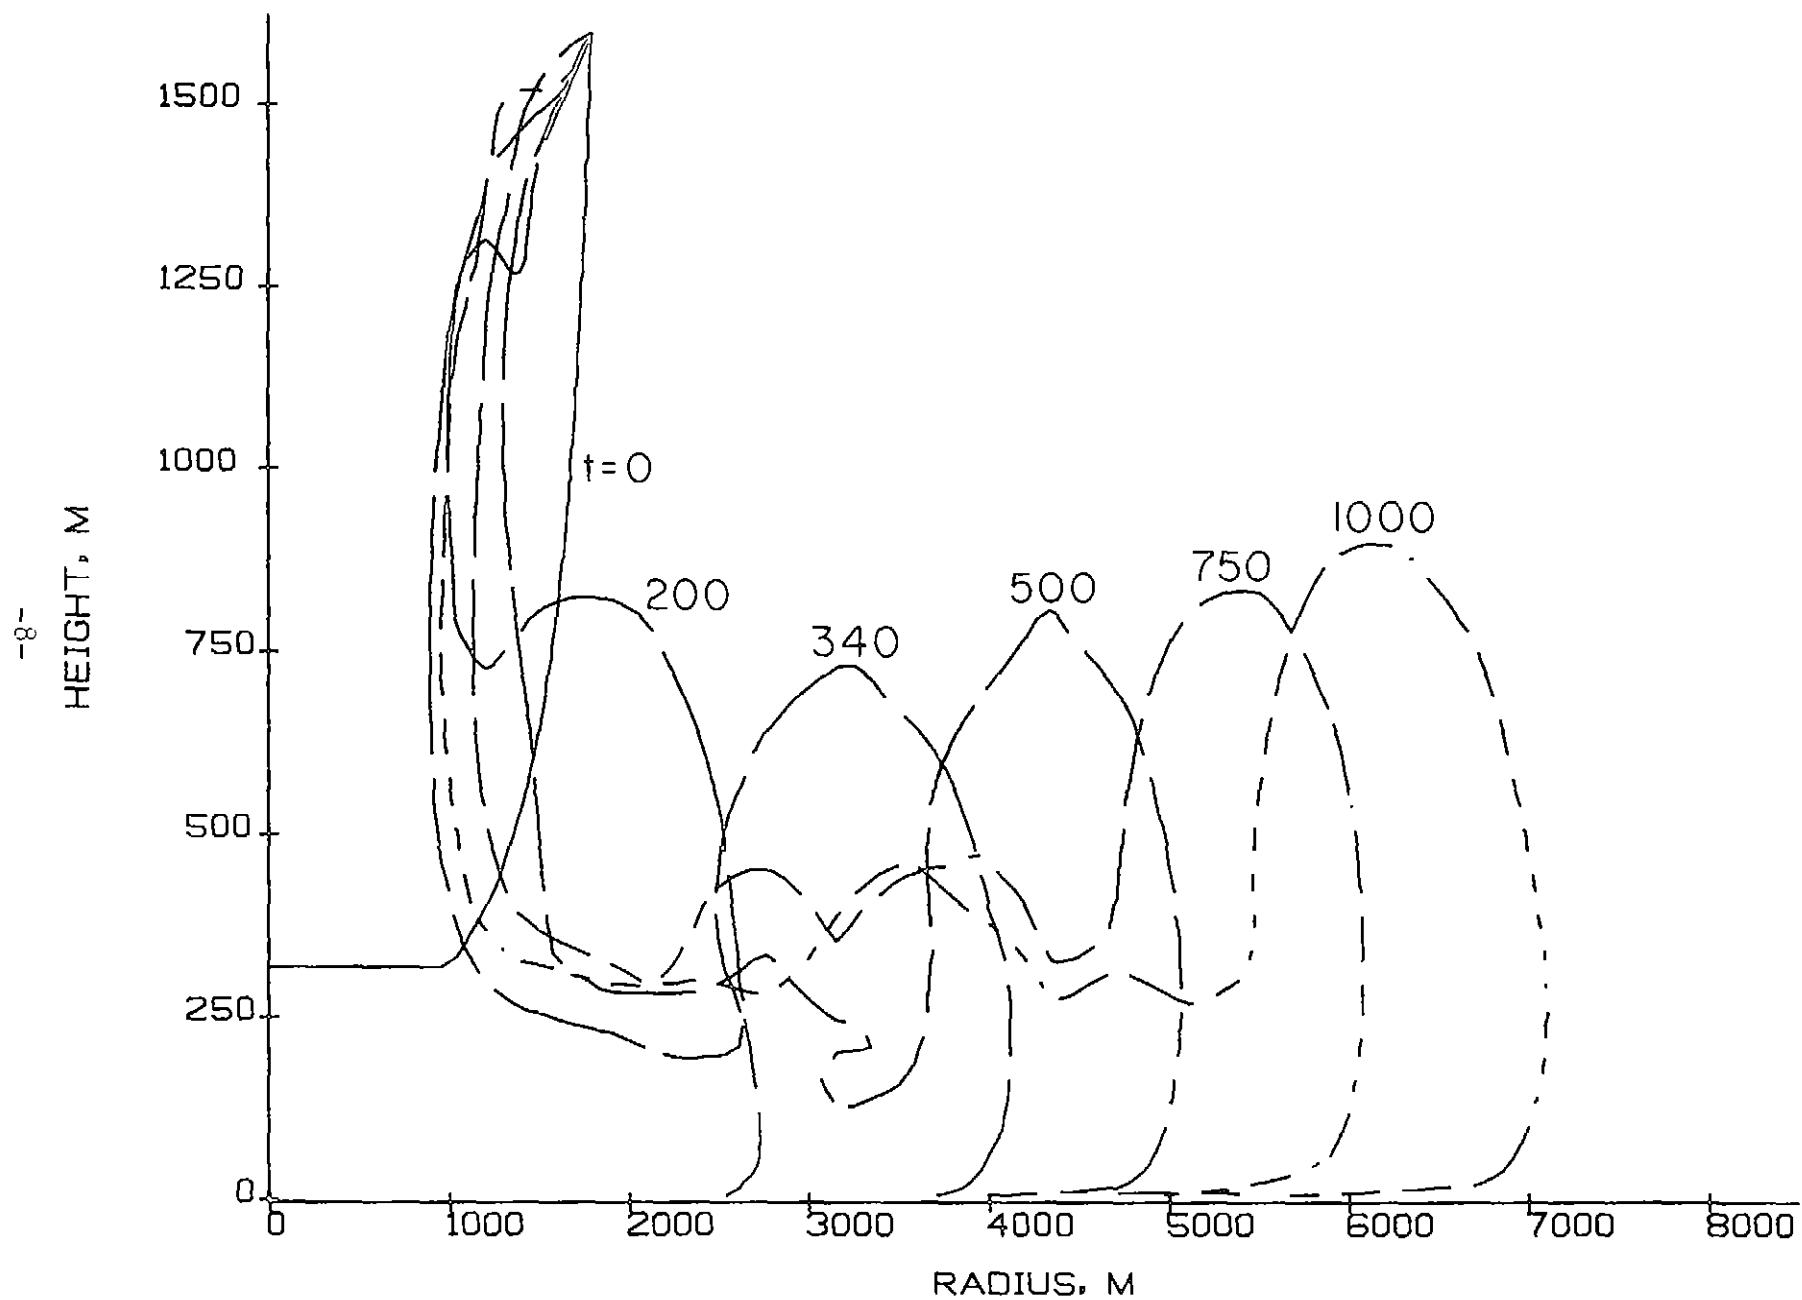
Figure 2.3.1. Growth of axisymmetric gust front as illustrated by the  $M=2.0$  contour at  $t = 0, 200, 340, 500, 750, 1000$  sec.

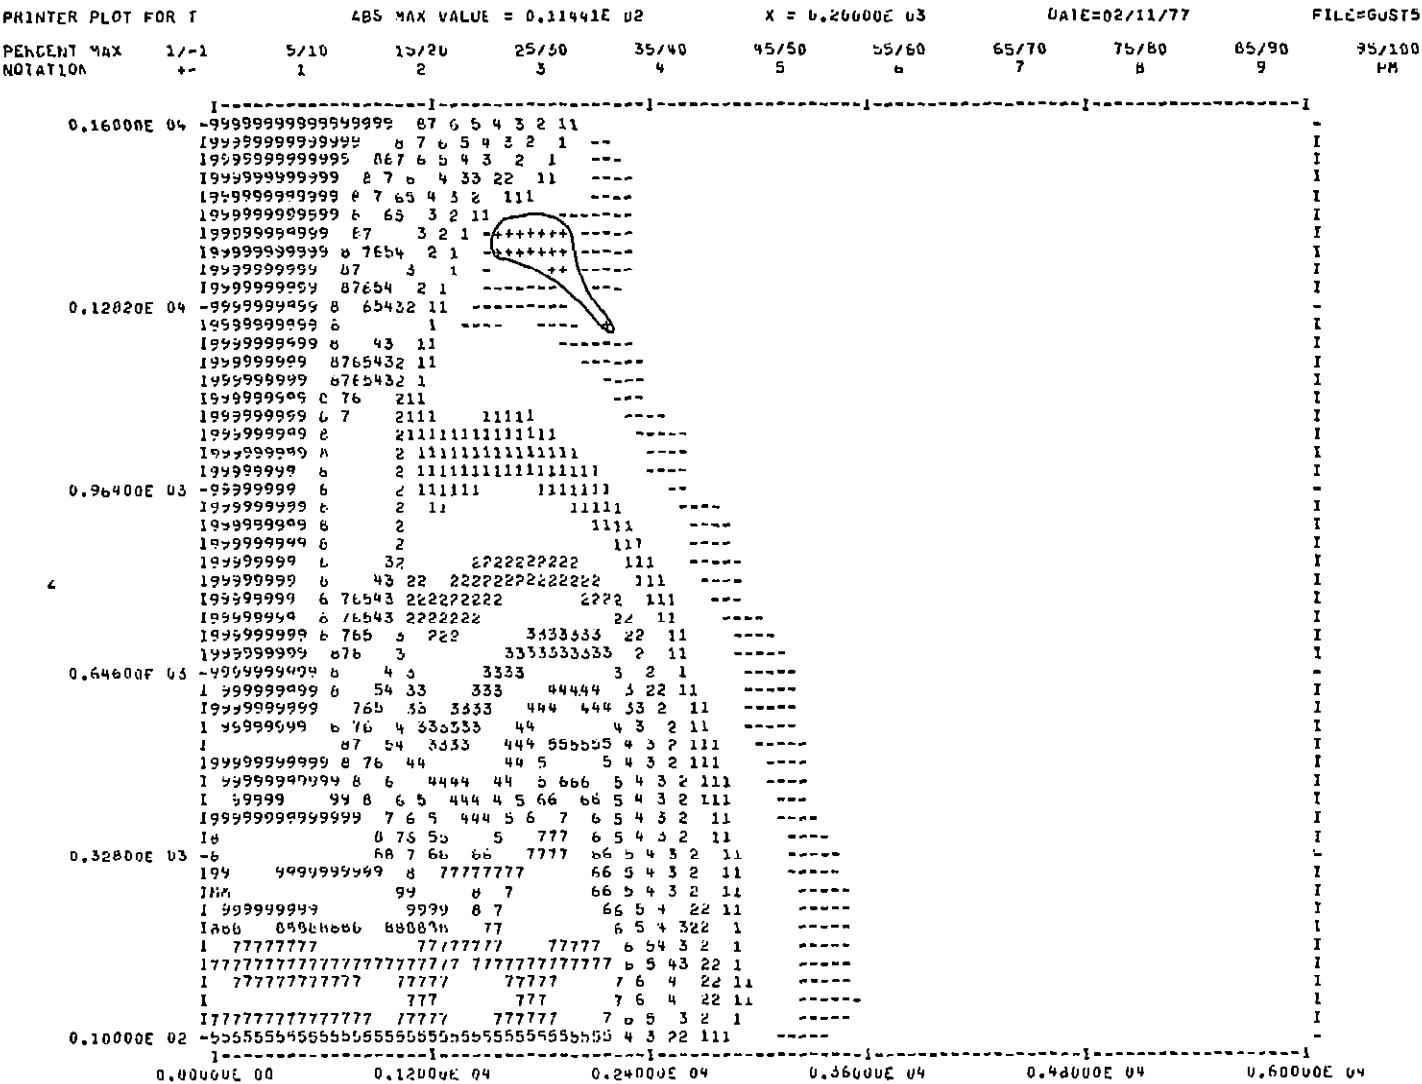
Figure 2.3.2. Normalized temperature contours as a function of  $z$  and  $R$  for an axisymmetric gust front with a 2000 m radius downdraft at  $t = 200$  sec. [The numbers represent the percentage of the maximum value indicated across the top. The same number may represent either a + value. The P represents a positive maximum and M as minimum. The zero contour is outlined.]

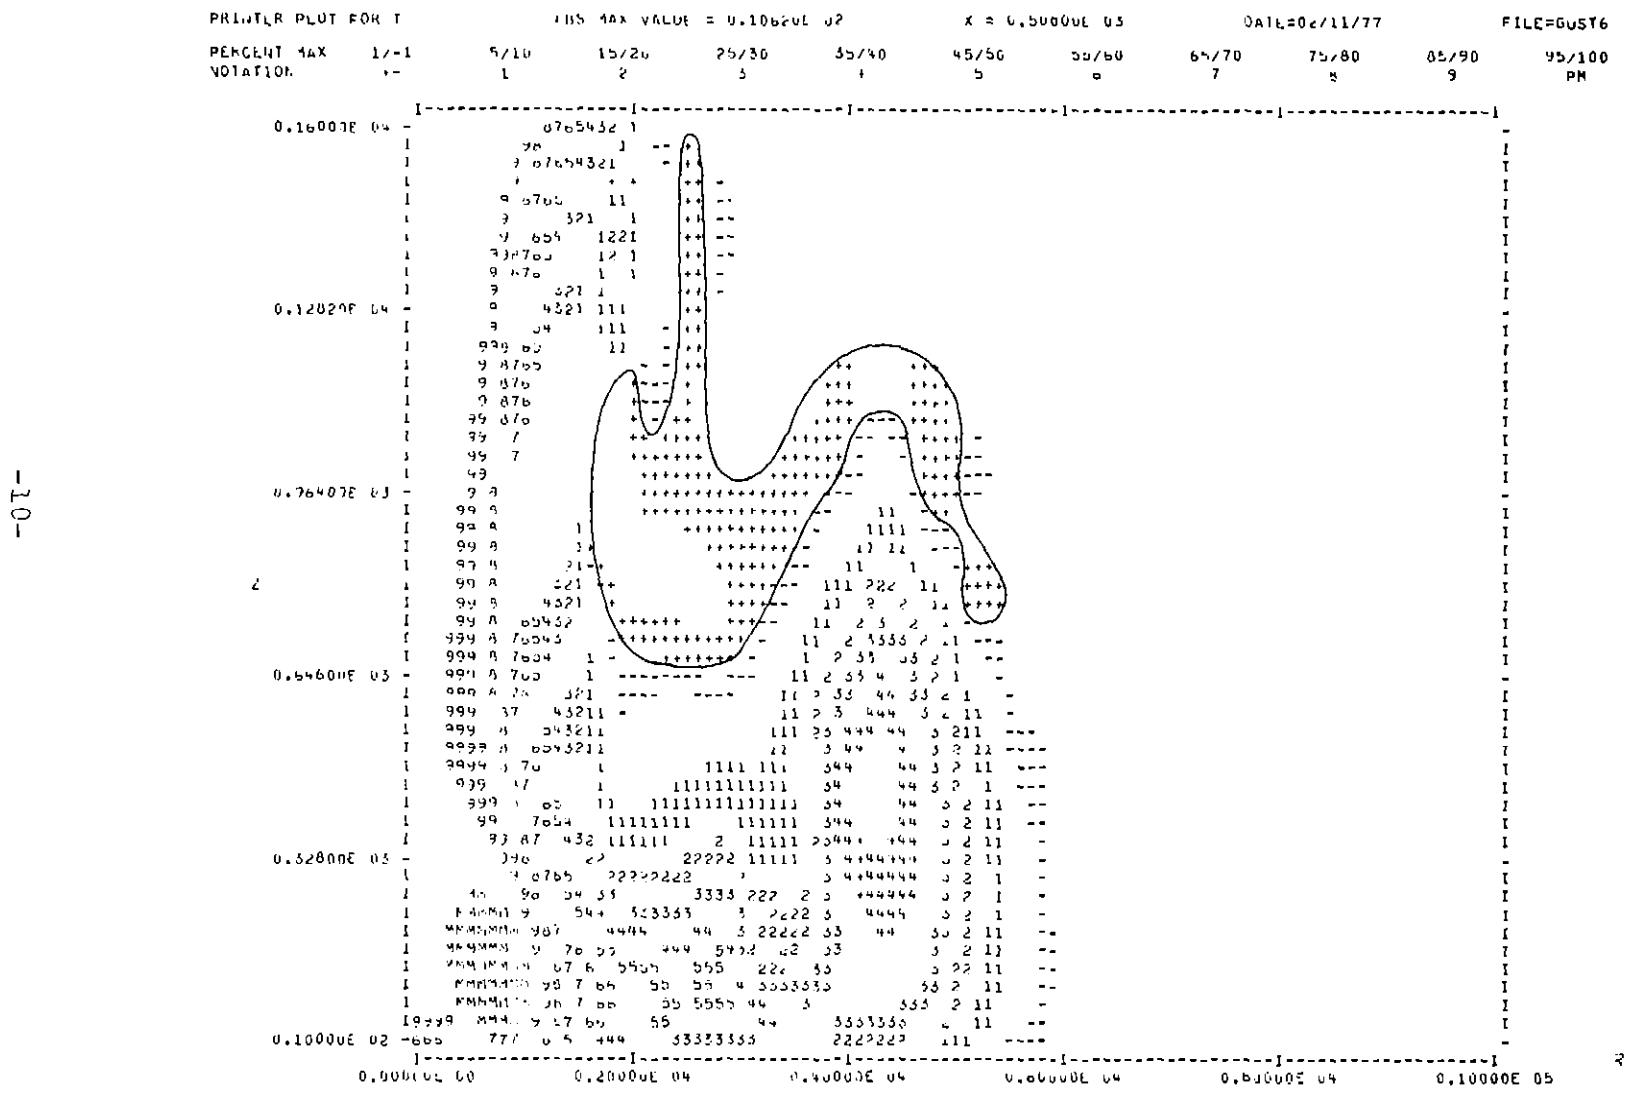
Figure 2.3.3. As above but  $t = 500$  sec. [See figure 2.3.2 for explanation of notation.]

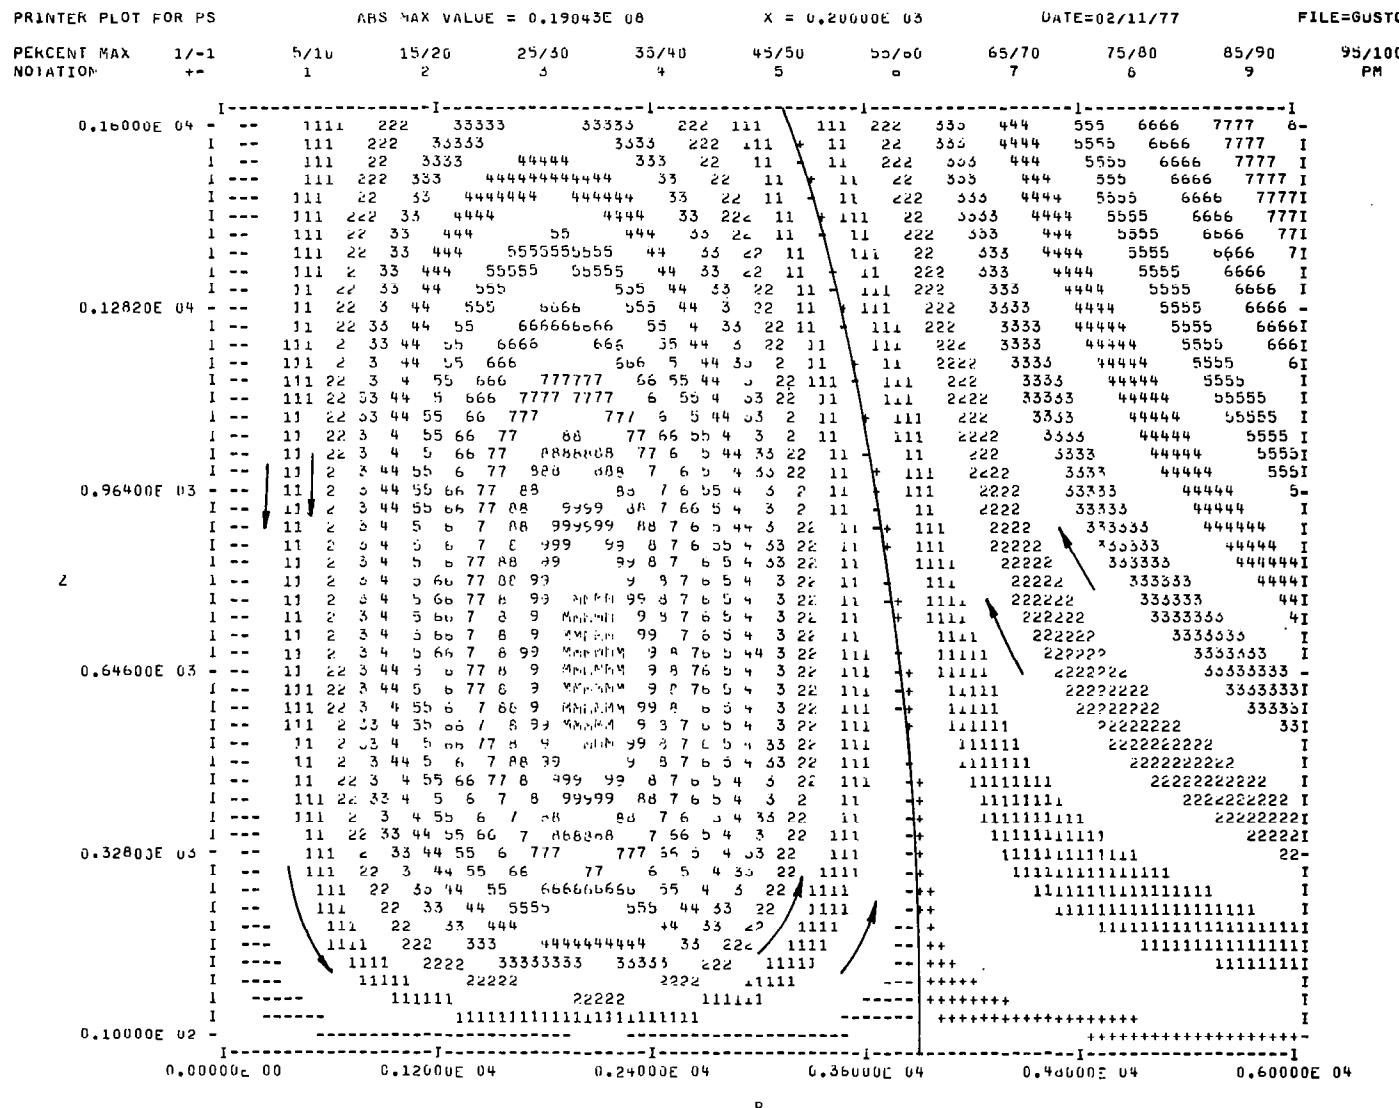
Figure 2.3.5. Normalized stream function contours as a function of  $z$  and  $R$  for an axisymmetric gust front with a 2000 m radius downdraft at  $t = 200$  sec. [See figure 2.3.2 for explanation of notation.]

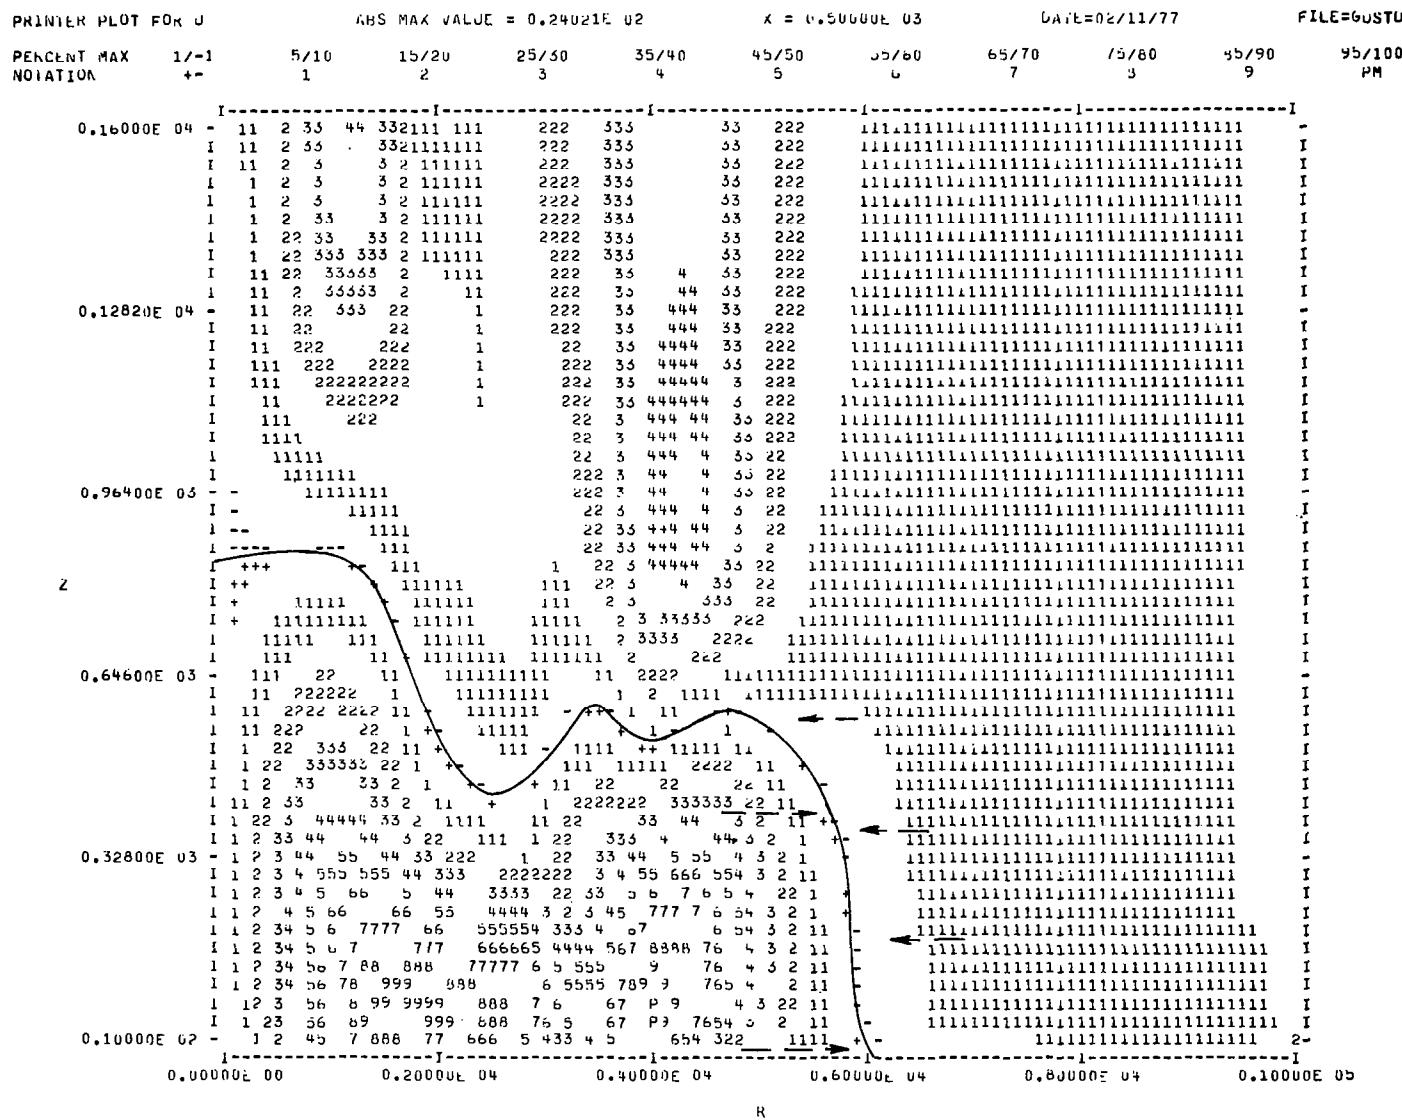
Figure 2.3.9. As above but  $t = 500$  sec. [See figure 2.3.2 for explanation of notation.]

The radial velocity  $U$ , in figures 2.3.8 - 2.3.10 shows a line of demarcation between flows away from and toward the axis lying between 600 m - 1 km. Its maximum value is about 24 m/sec near the surface. At the two later times this line has dropped closer to the surface (about 300 m) with mass continuity then permitting the maximum velocity to remain nearly constant. Arrows indicate the flow direction. The vertical velocity  $W$  in figures 2.3.11 - 2.3.13 shows the very strong downdraft near the centerline. Although we are forcing an inflow of 10 m/sec, the simulation determines a downward jet of over 18 m/sec throughout most of the run. Secondary up- and down-drafts near the gust front develop in the later stages of the run.

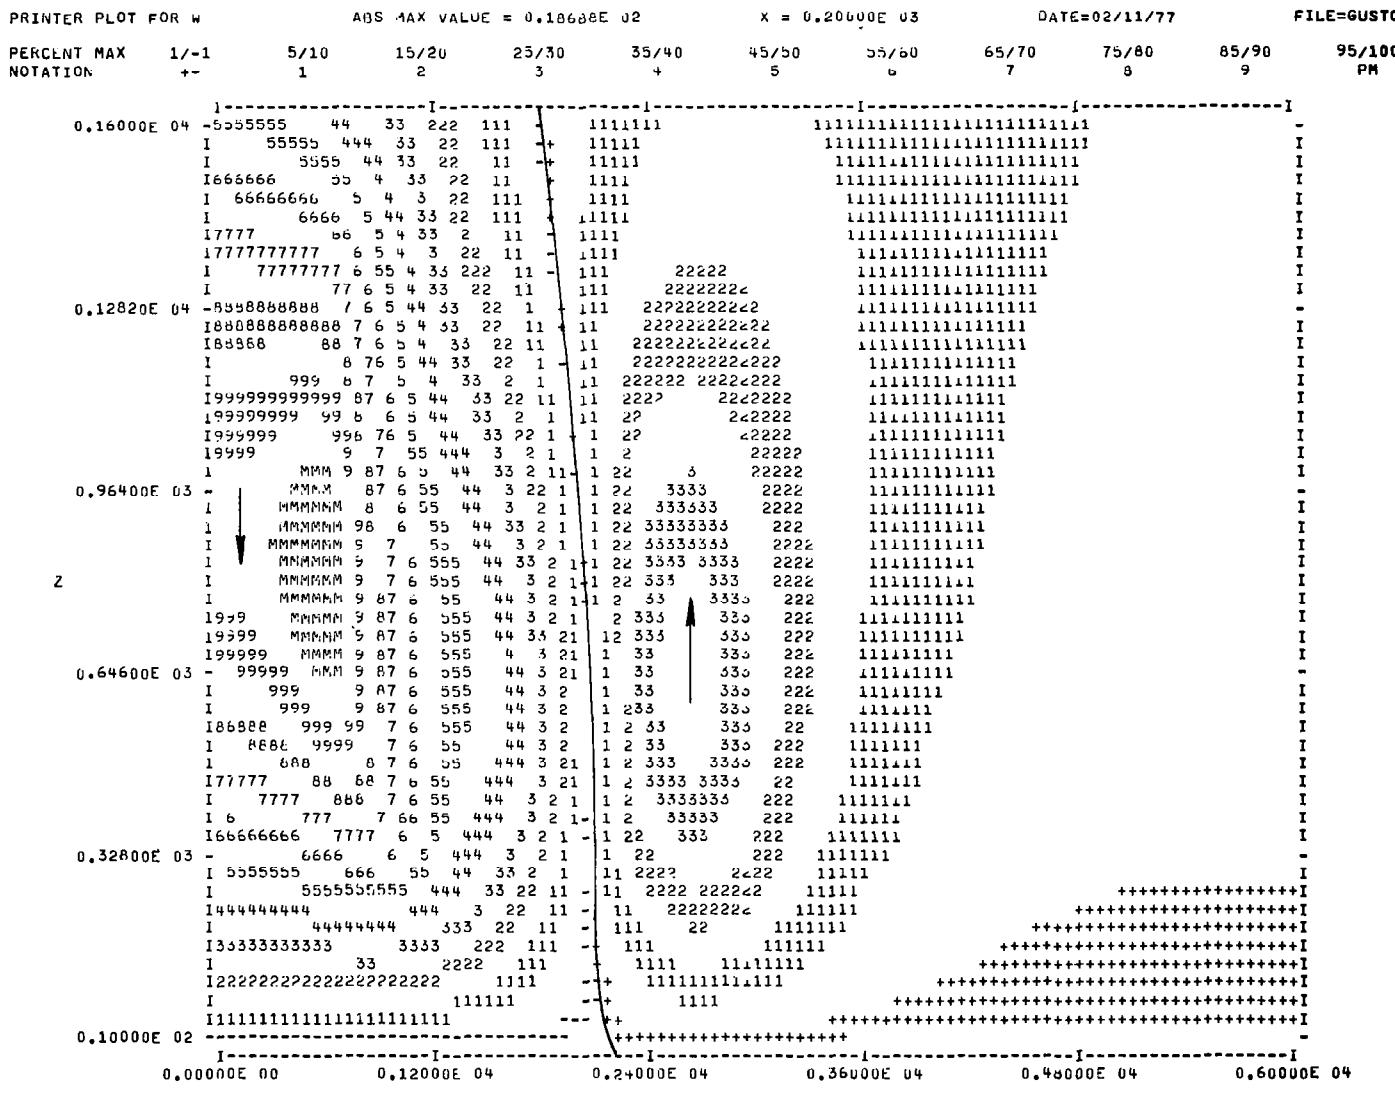
Figure 2.3.11. Normalized mean vertical velocity contours as a function of  $z$  and  $R$  for an axis-symmetric gust front with a 2000 m radius downdraft at  $t = 200$  sec. [See figure 2.3.2 for explanation of notation.]

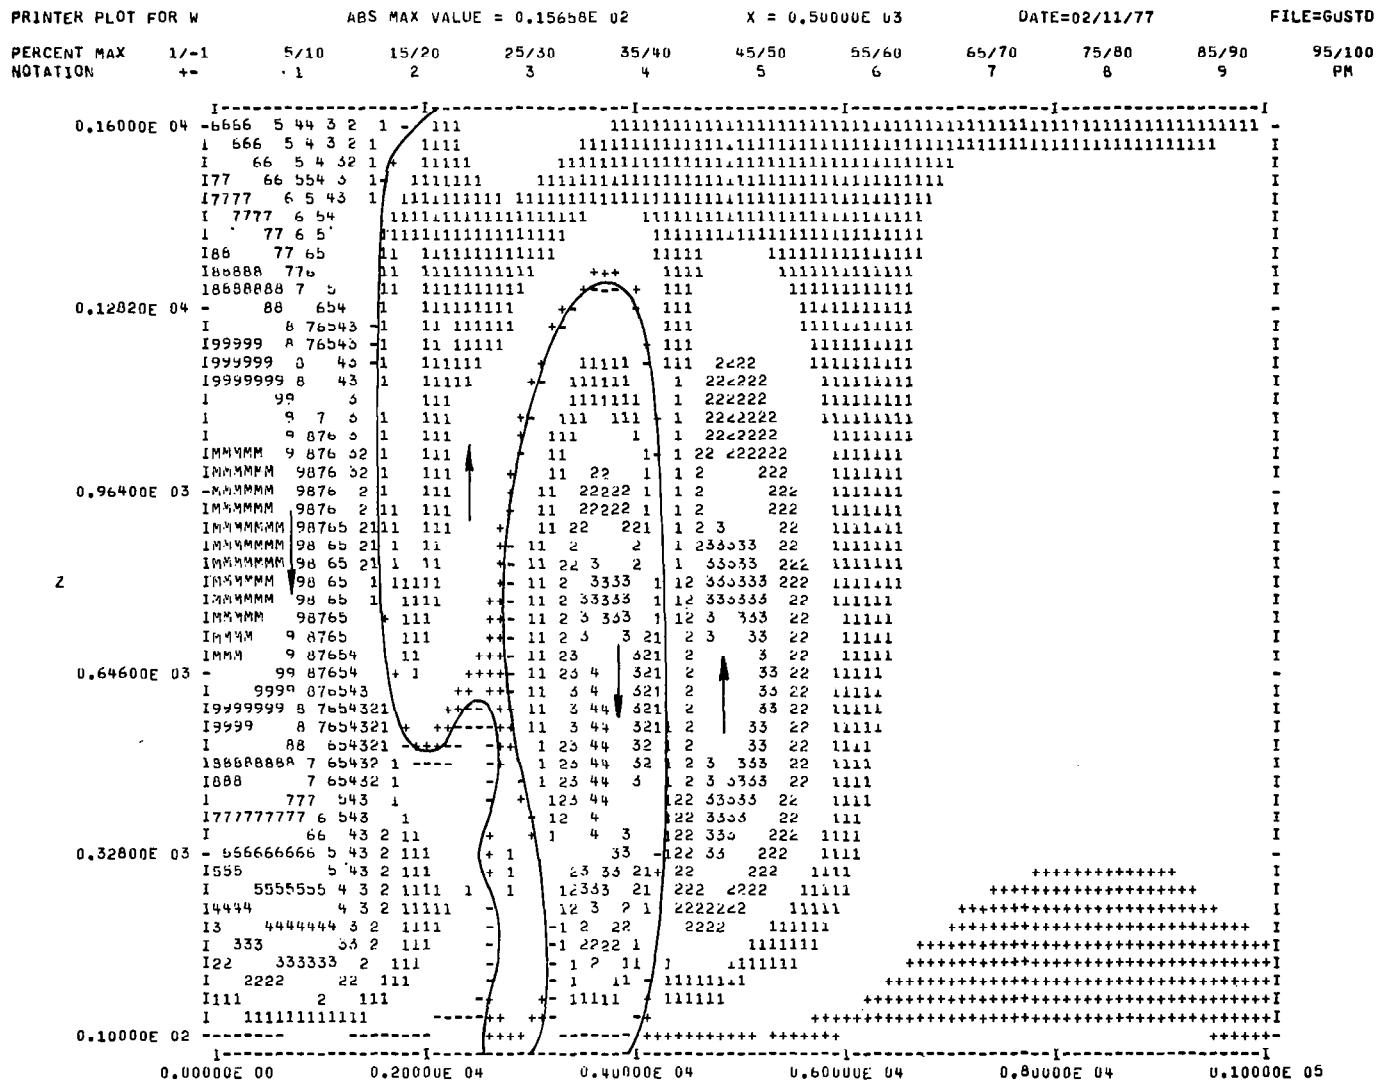
Figure 2.3.12. As above but  $t = 500$  sec. [See figure 2.3.2 for explanation of notation.]

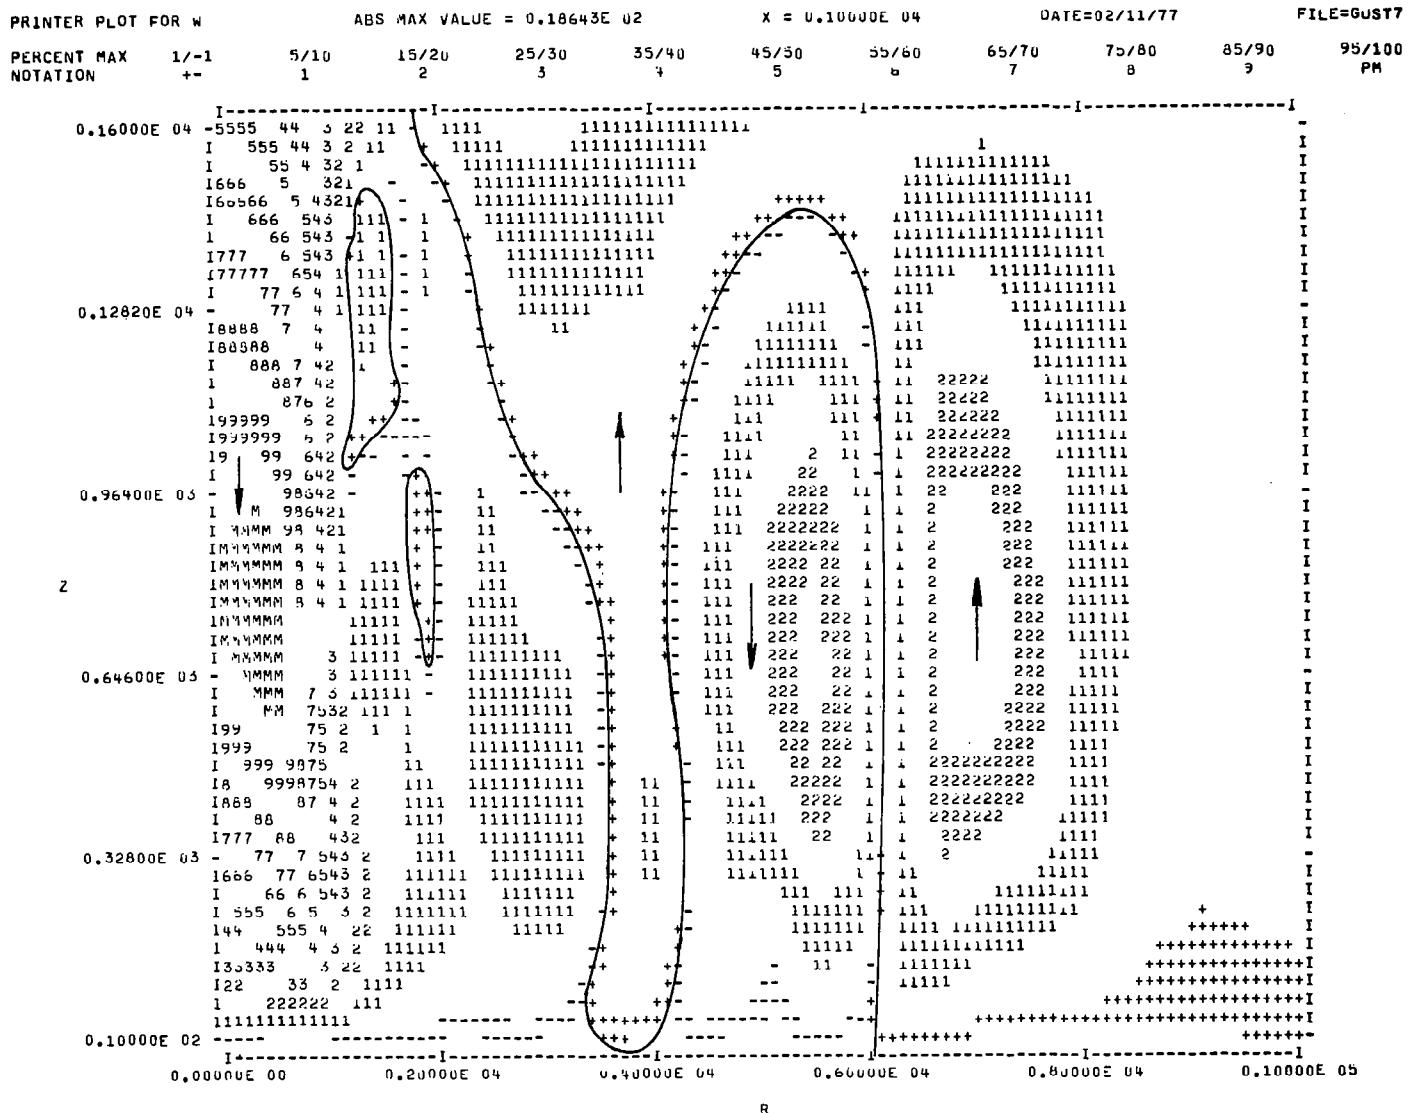
Figure 2.3.13. As above but  $t = 1000$  sec. [See figure 2.3.2 for explanation of notation.]

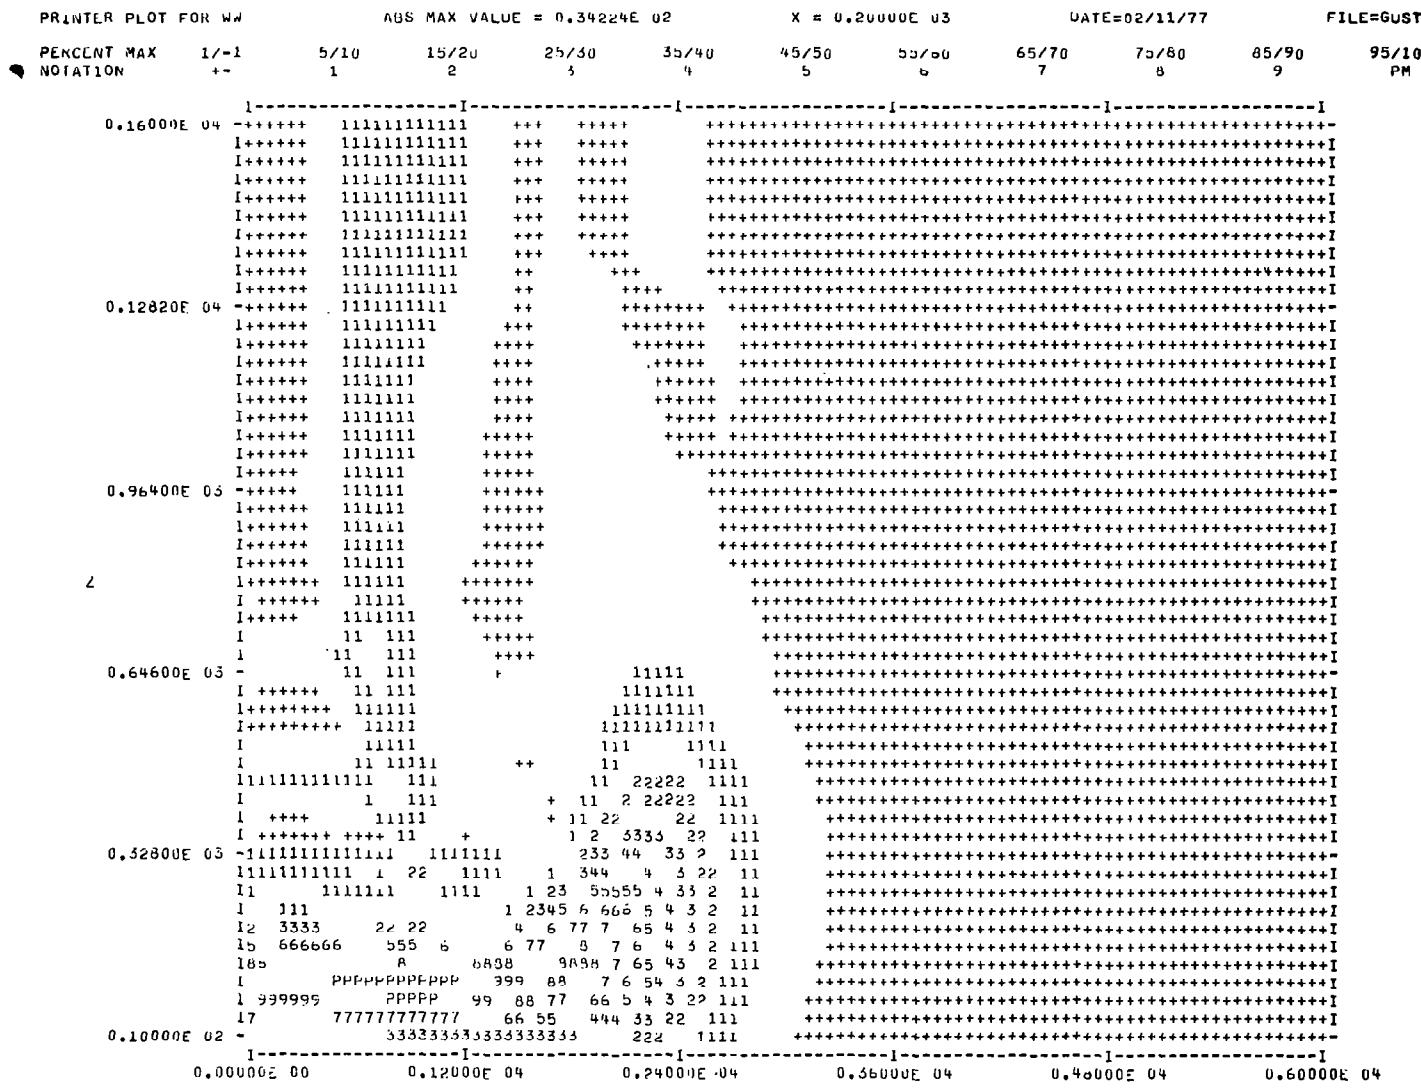
Figure 2.3.14. Normalized variance of vertical velocity contours as a function of z and R for an axisymmetric gust front with a 2000 m radius downdraft at t = 200 sec. [See figure 2.3.2 for explanation of notation.]

We show the vertical energy component  $w'w'$  in figures 2.3.14 - 2.3.16. At  $t = 200$  sec the largest values occur in the region of greatest production - near the centerline at the surface. Subsequent profiles at 500 and 1000 sec show the development near the axis, and the decay of generated turbulence in the gust front region.

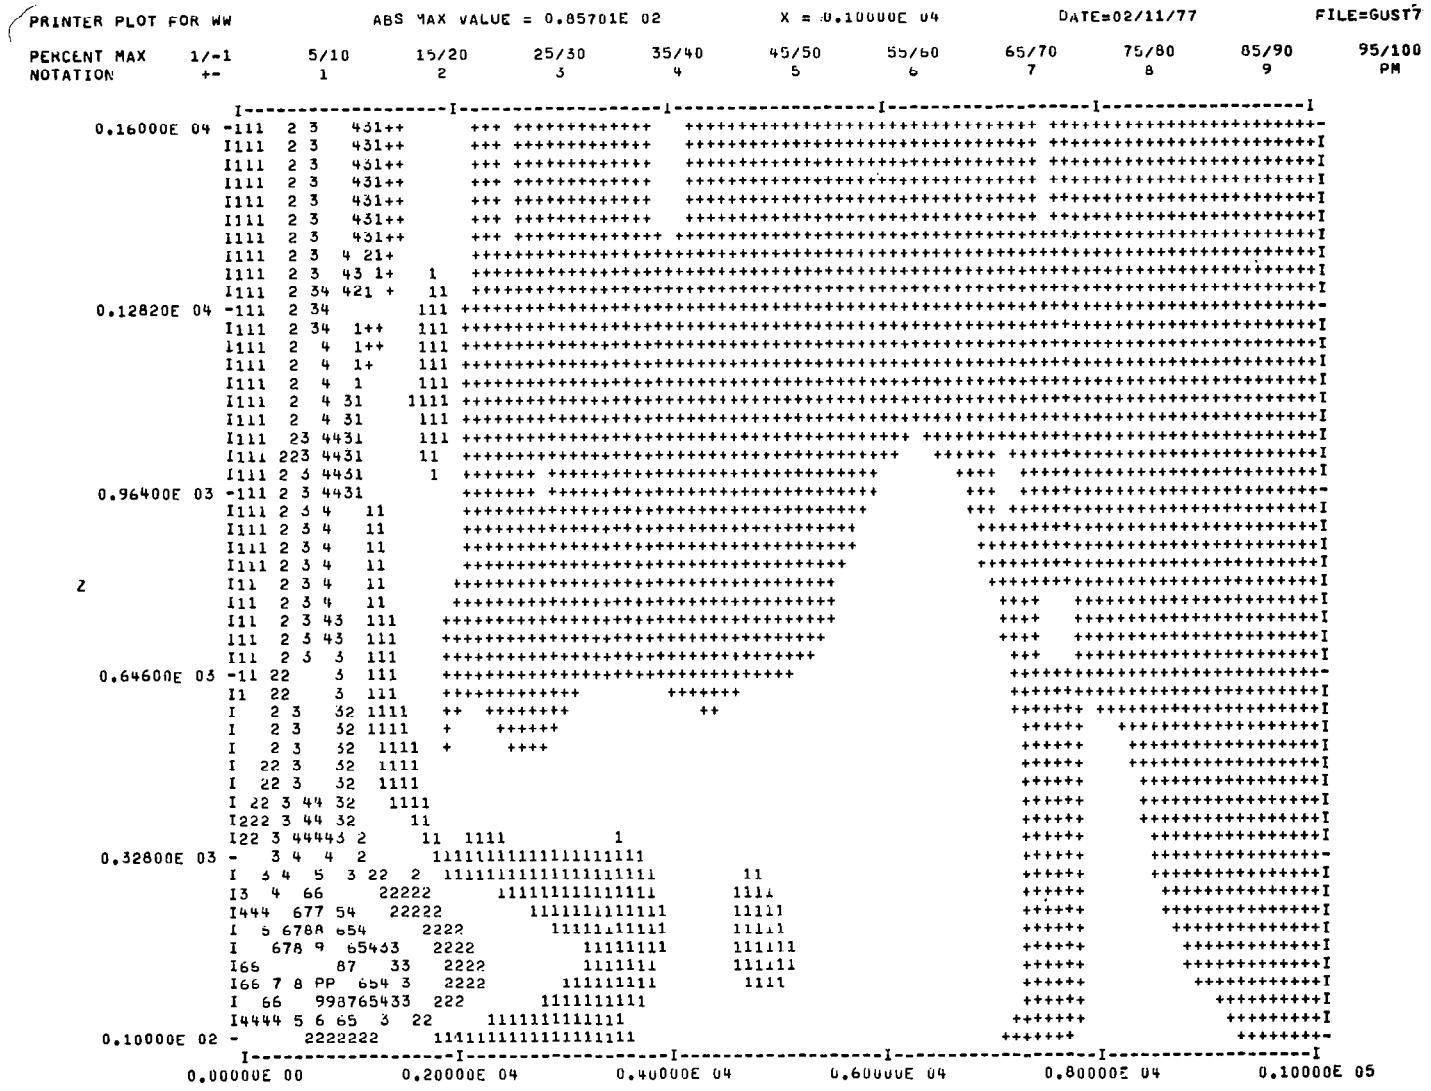
Figure 2.3.16. As above but  $t = 1000$  sec. [See figure 2.3.2 for explanation of notation.]

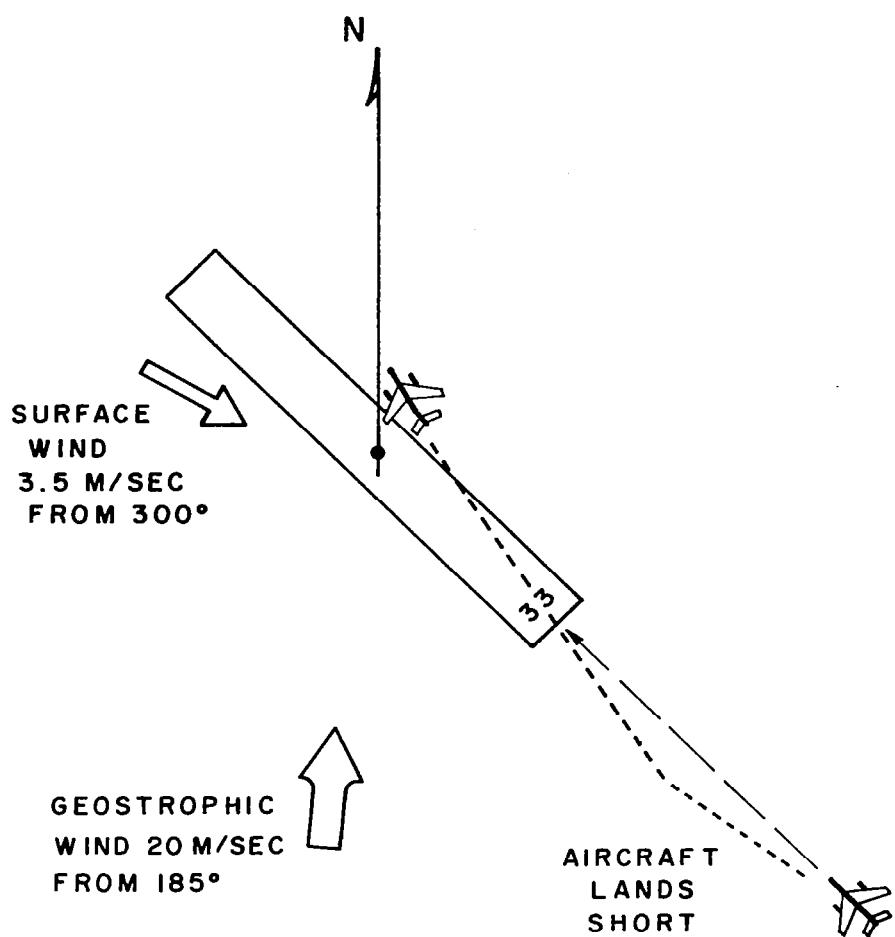
Figure 3.2.1. Aircraft-runway-winds orientation diagram for Boston, December 17, 1973 accident.

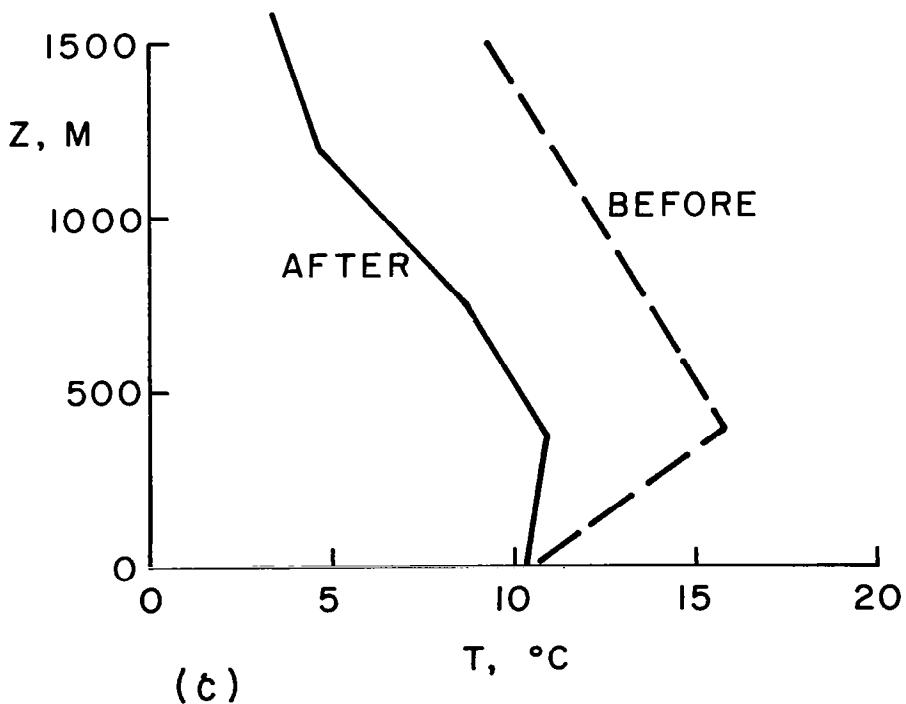
Figure 3.2.7. Altitude profiles for; a) mean geostrophic velocity component parallel to runway (+  $U_g$ , tailwind), b) mean wind velocity component perpendicular to runway (+  $V_g$ , crosswind from right), c) temperature before and after the Boston December 17, 1973 accident.

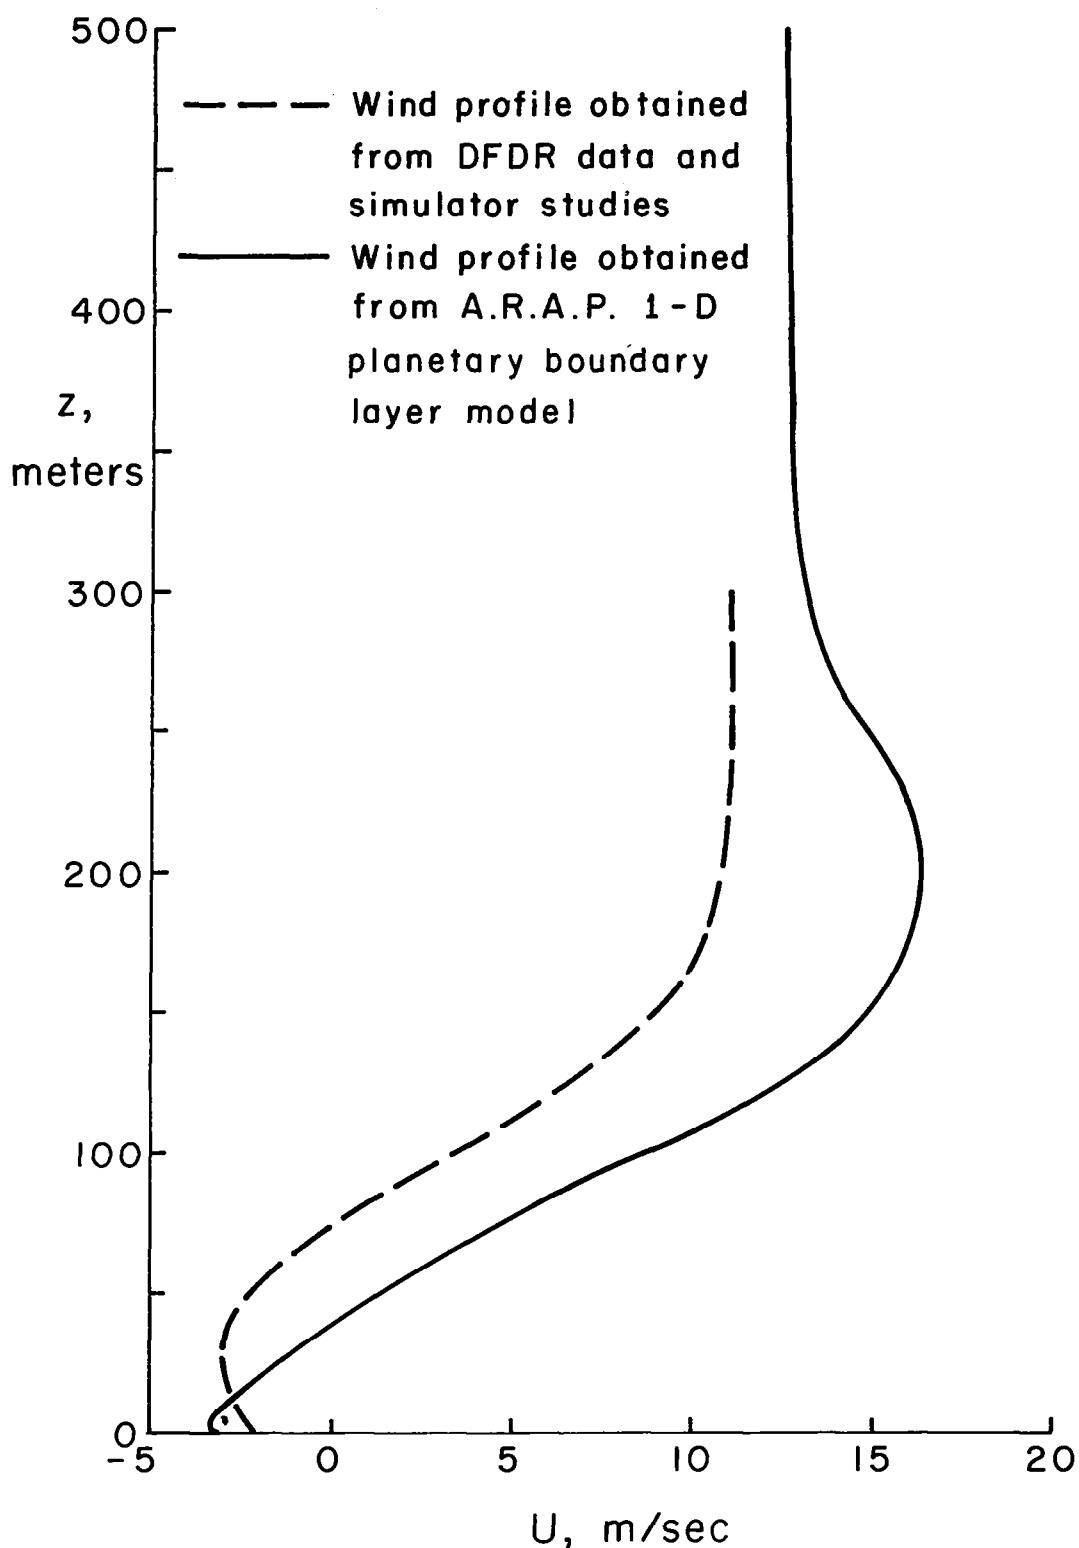
Figure 3.2.8. Altitude profile of mean wind velocity component parallel to runway (+  $U$ , tailwind) for Boston, December 17, 1973 accident.

The significant meteorological conditions in this case were rain and fog at the airport. A precipitation area 400 km in diameter encompassing the airport was observed on the Chatham weather radar. Only weak precipitation echoes showed over the accident site (figure 3.2.2). Surface weather charts showed a front in the general vicinity of the accident (figures 3.2.3-3.2.6). In addition, there existed a temperature differential between the land and the ocean. Either or both of these phenomena may have contributed to the geostrophic velocity differences existing between the surface and 850 mb altitude at 1300 l.s.t. and at 1600 l.s.t. The time variation of the geostrophic velocity distribution used was a linear interpolation between the profiles shown in figure 3.2.7 down to 200 m. Below this altitude the geostrophic velocity profile was altered to account for a horizontal temperature gradient assumed to start one hour before the accident (1443 l.s.t.) and remain until 1900 l.s.t. The magnitude and shape of the change in geostrophic velocity assumed is seen in the profile for  $U_g$  at 1900 l.s.t. The resulting velocity profiles at the time of the accident along with estimates obtained from flight recorder data and simulation studies are shown in figures 3.2.8 and 3.2.9.

The agreement in wind shear ( $.13 \text{ sec}^{-1}$ ) and surface velocity is good. However, the results obtained from the A.R.A.P. weather model extend the shear over a larger altitude interval, thus resulting in a 5 m/sec greater change in forward velocity. Agreement could be further improved by increasing the surface roughness

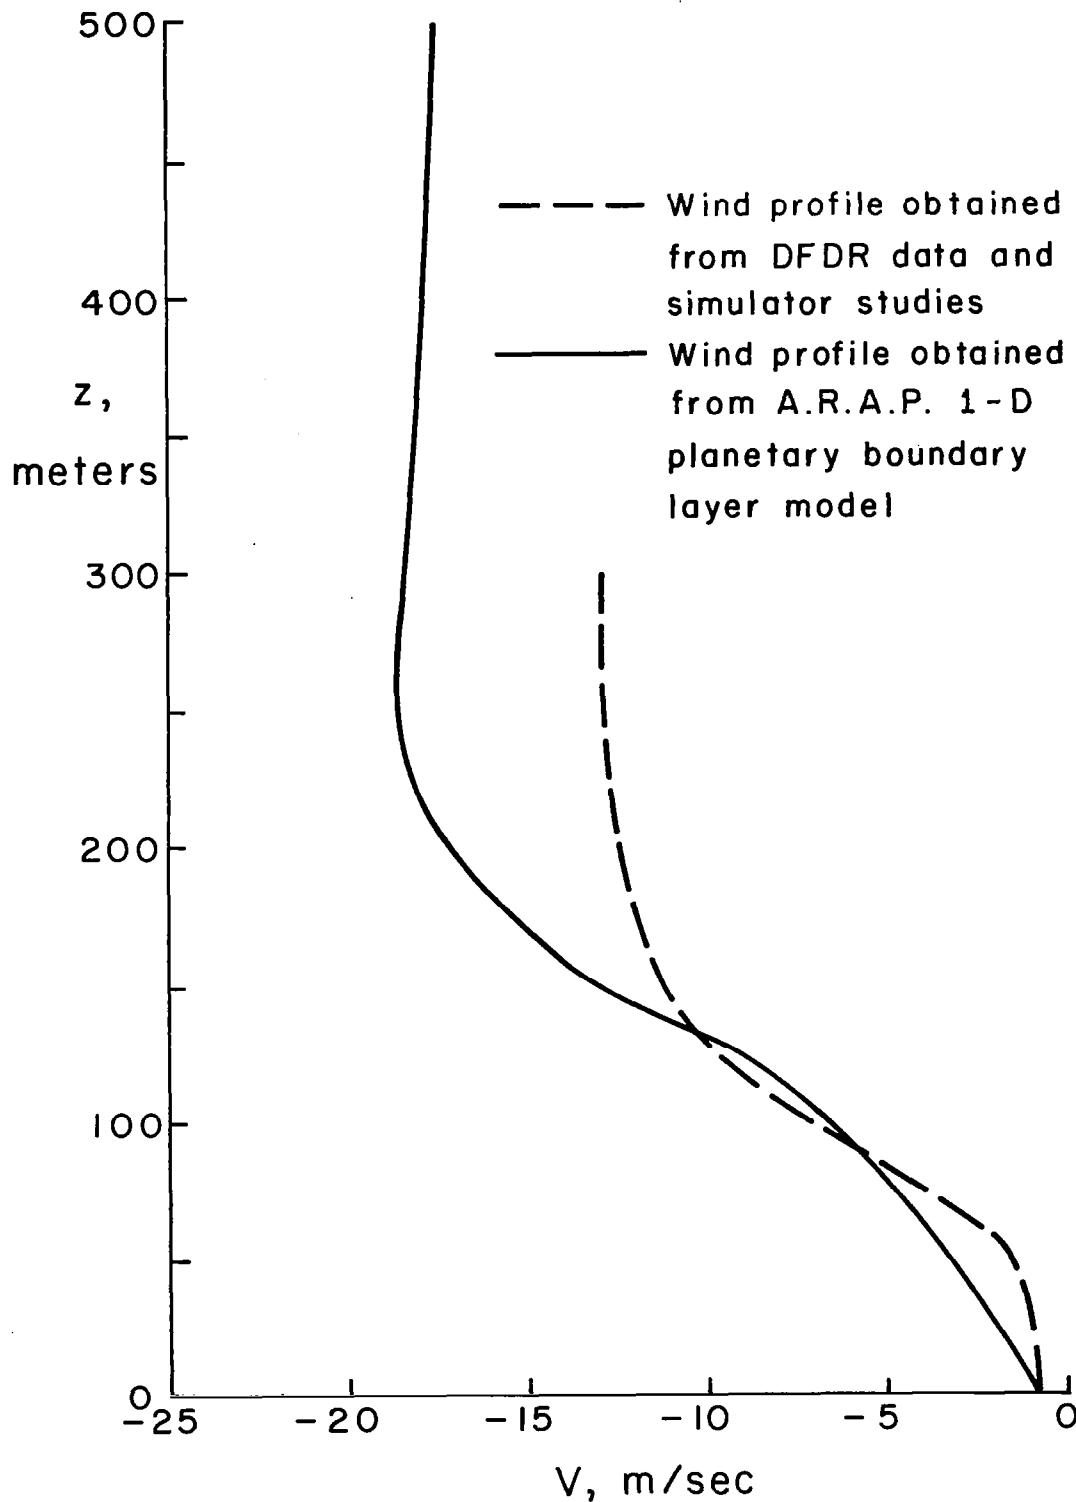
Figure 3.2.9. Altitude profile of mean wind velocity component perpendicular to runway (+  $V$ , crosswind from right) for Boston, December 17, 1973 accident.
